Photos taken during the shipyard visit on 2025-04-08

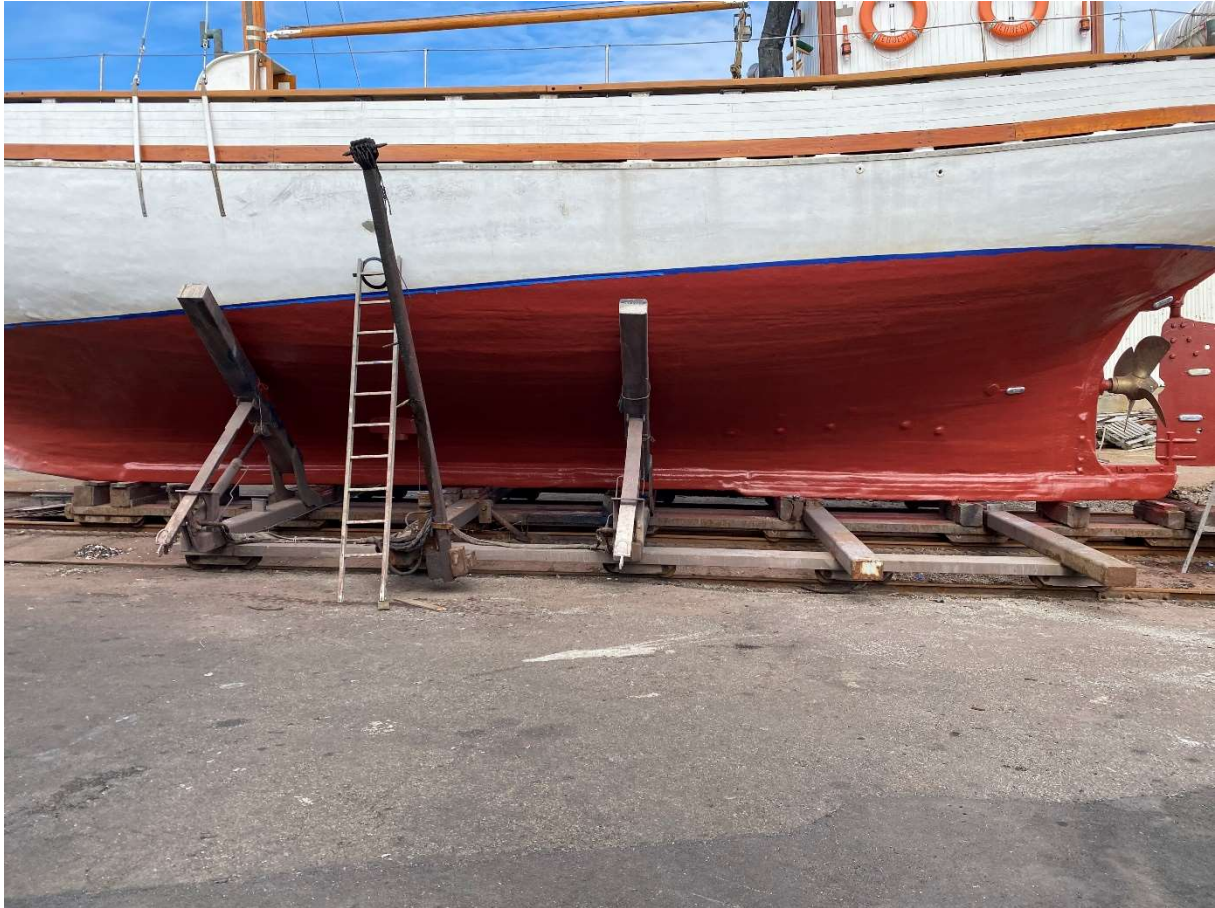
This is a normal repair, as mooring with the bow towards the islands in the archipelago is commonly used
