INSPECTION CARD HYDRAULIC SHIP-CRANES

Customer Vegsund Slip AS			Service contract no. -	Order no. 285530
Installation Fastmontert hydraulisk kran		Product Palfinger	Equipment PALFINGER PK150002 MH	
Location OV SKOMVÆR, FWD/STB		Serial no. 50003084	Int.no N/A	Inspection type SK
Certificate.no KISM-8599-S1	Other information 5Y insp og test. Kran funnet med mangler/feil som må utbedres. Midlertidig godkjent (6mnd) slik at avvik kan utbedres			Control date 20.jul.2023
Flag state Norge	Test load Ton/Date 3.1 / 20.jul.2023	Wire certificate -	Next 5 year control 20.jul.2028

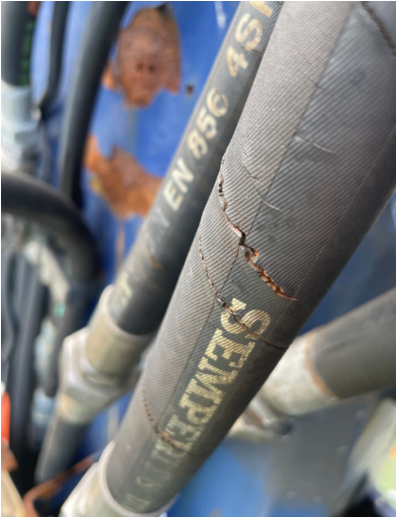
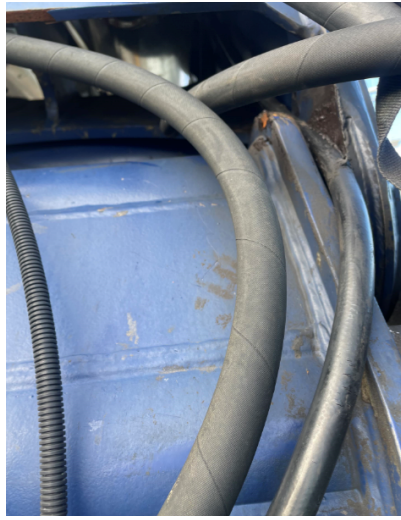
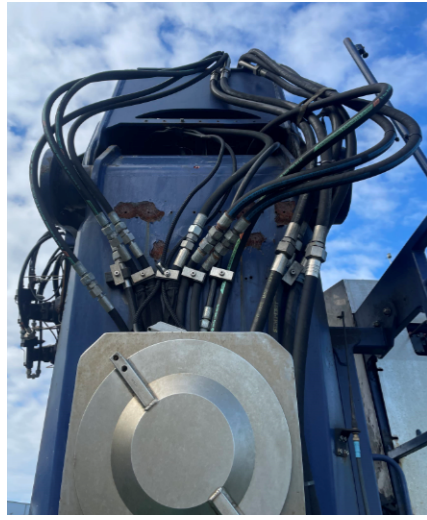
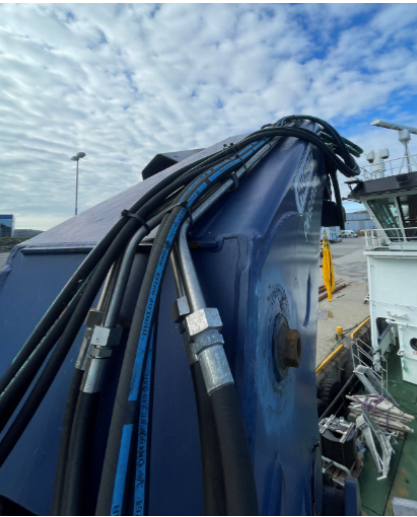
5.2 All hoses and pipes in the hydraulic system \$9

POS.NR	INSPECTION POINT	DESCRIPTION OF FINDINGS AND RECOMMANDATIONS	ACTION POINT	R	S	REP
5.2	5.2 All hoses and pipes in the hydraulic system §9	Skade på flere hydraulikkslanger bak på konge. Slanger som ligger på konge/hovedbom og vippbom må rutes opp og festes skikkelig, da de ligger i fare for å komme i klem. Alle slanger som har skade, tegn til slitasje eller eldre en 5 år må skiftes.	Performed by Customer	X

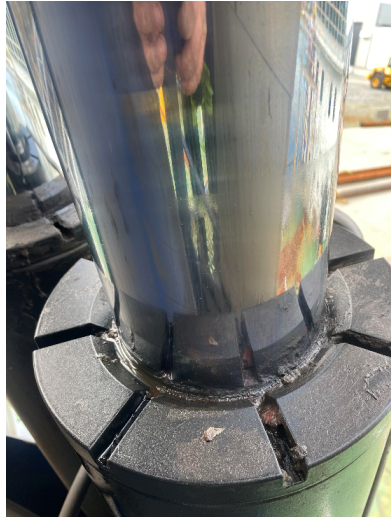
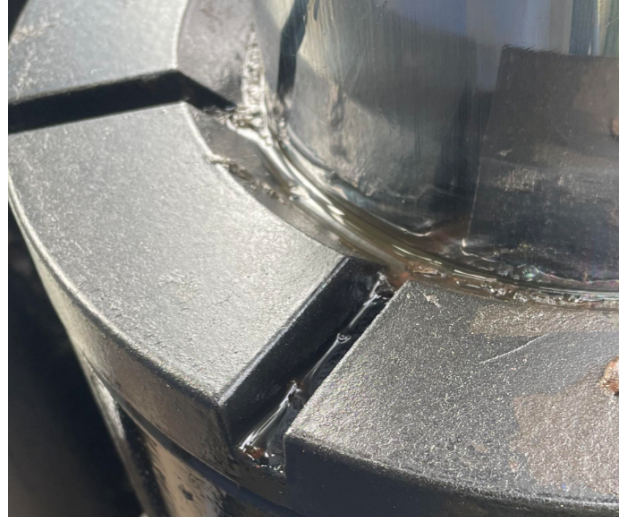
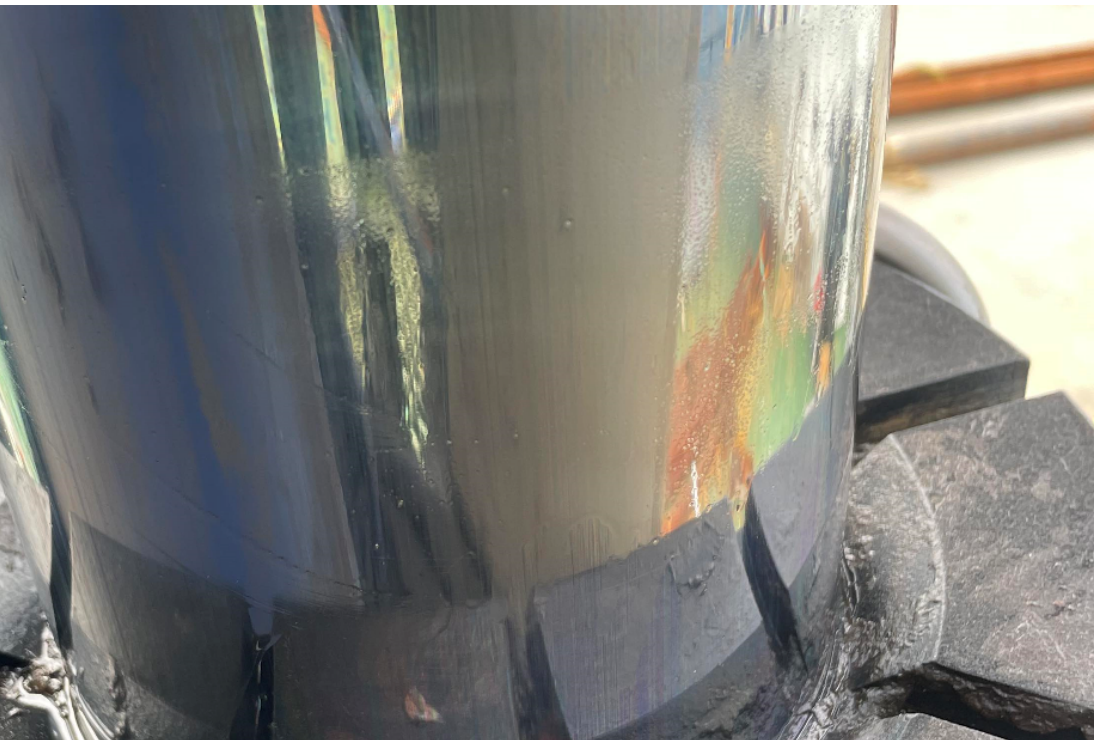
5.5 Hydraulic cylinders \$9

5.5	5.5 Hydraulic cylinders §9	Lekkasje fra høyre hovedløftesyylinder. Man kan tydelig se at det samler seg olje i topp av pakkboks, og stempelstangen er våt. Anbefaler ompakking av sylinder (skifte tetninger i pakkboks og stempel). Vippsylinder viser tegn til svetteing- må holdes under oppsyn og se om det forverres	Performed by Customer	X

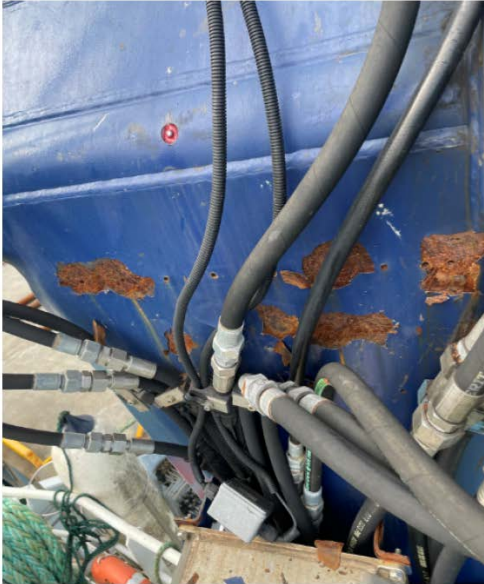
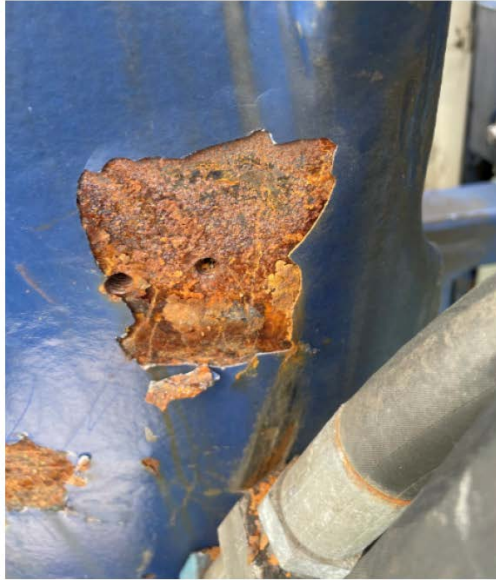
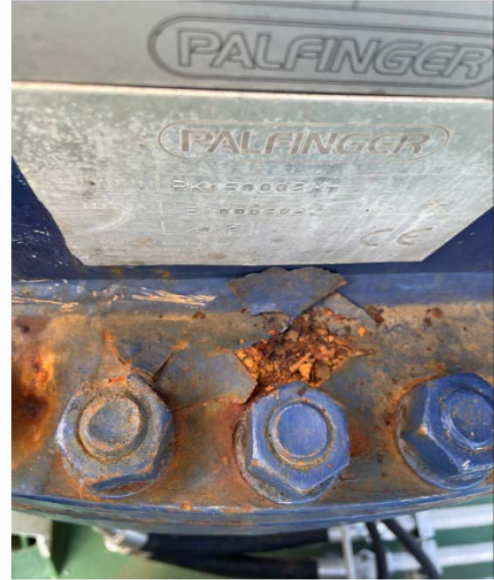
8.2	8.2 Rust / corrosion and paint damage §17 / §18	Finner flere områder på krankonge som er betraktelig rustskadet, spesielt i ryggen på krankonge. Ser også rustdannelse i krankongens stressområder. Dette kan være tegn på overbelastning og burde vært undersøkt nærmere i form av grundig rengjøring og NDT. Anbefaler (til å begynne med): grundig overflatebehandling slik at man kan få en oversikt over omfanget dette sprer seg over	Performed by Customer	X

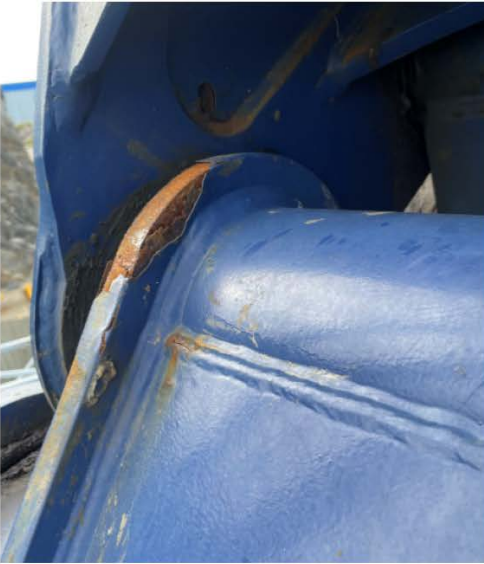
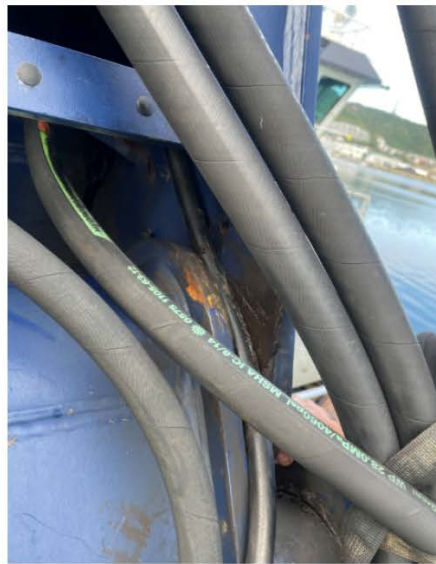
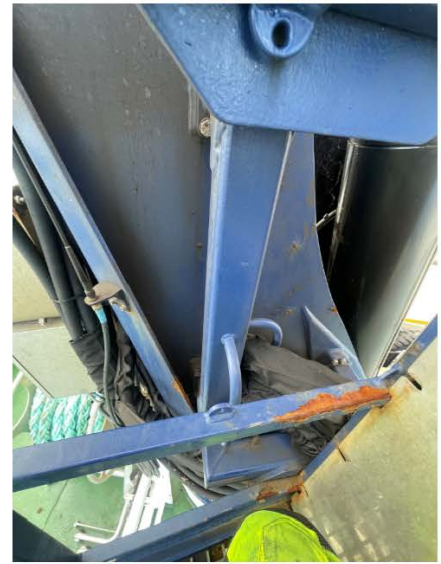
8.4	8.4 Ladders, stairs, walkways, railings, kick lists, safety hoops, repos, attachment point for fall protection etc. §9	Rustdannelser på krankorg. Anbefaler overflatebehandling	Performed by Customer	X

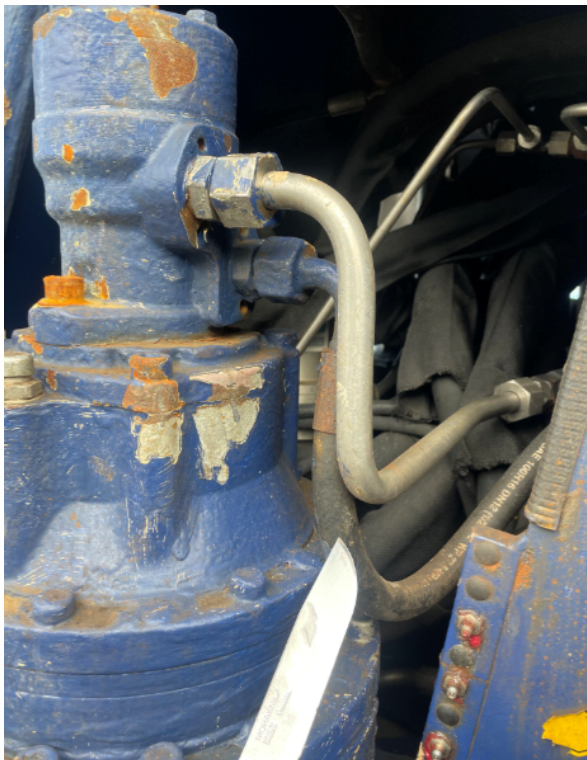
10.1	10.1 Motors, gear, brakes, couplings and hoses §9	Venstre gir: Det er montert slange på ene trykkløpet (der det skulle vært rør). Alle føringer montert etter lastholdeventil skal være med hydraulikkør. Må skiftes.	Performed by Customer	X
